# Comparative Study of NSDF Reference Sites

**NEAR SURFACE DISPOSAL FACILITY (NSDF)**

Presentation to the Canadian Nuclear Safety Commission

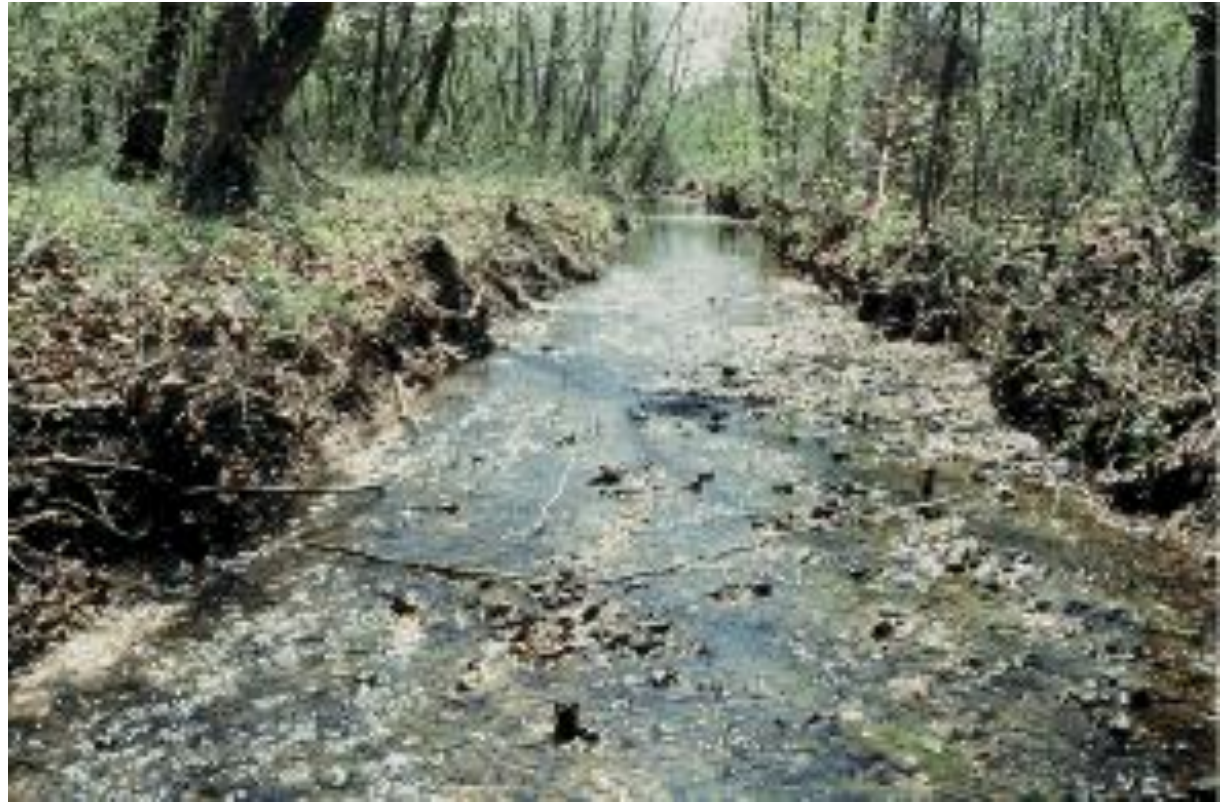
Bear Creek, at Oak Ridge National Laboratory Site

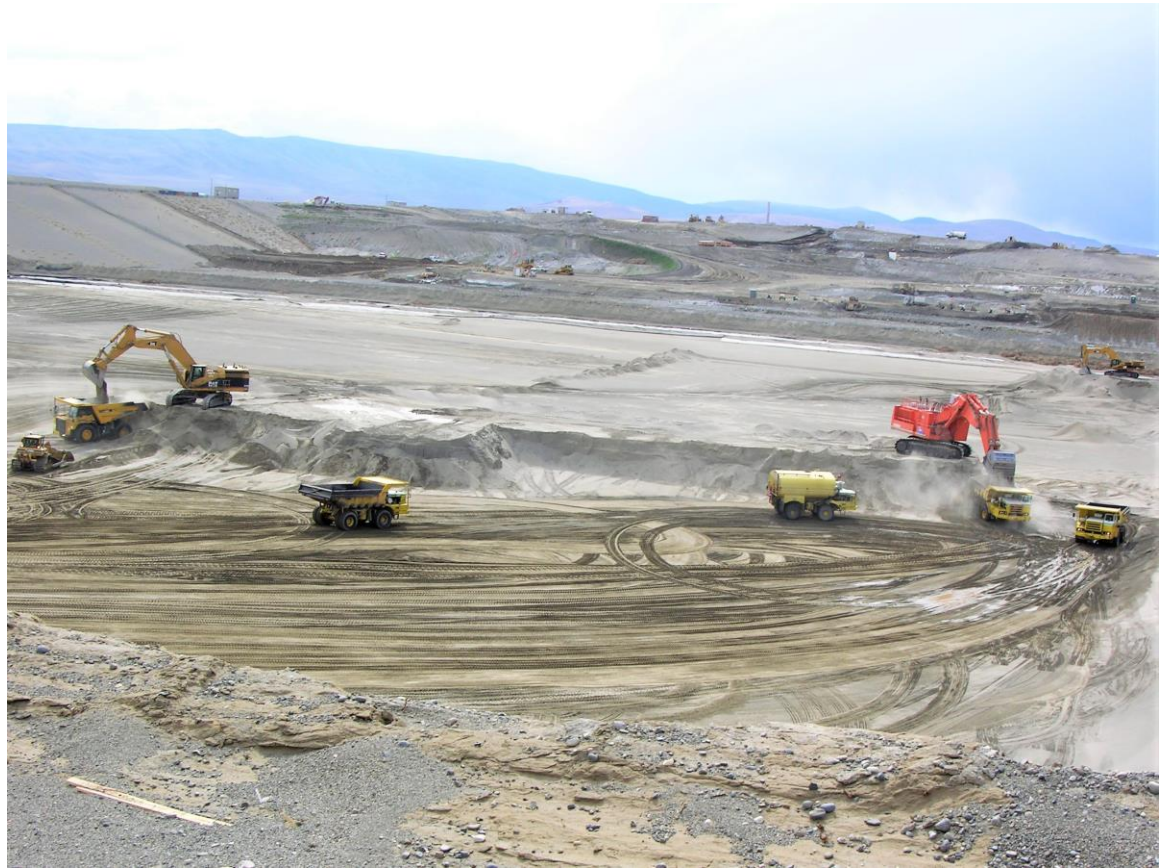
Environmental Restoration Disposal Facility – Super Cells 9 & 10 Construction
